Staff Report- December 10, 2013
222 West Lafayette Avenue
Baltimore City Historic District- Bolton Hill

Plan: Demolish existing rear garage
Staff Presenter: Stacy Montgomery
Applicant: Doris Low Kamenetz, owner

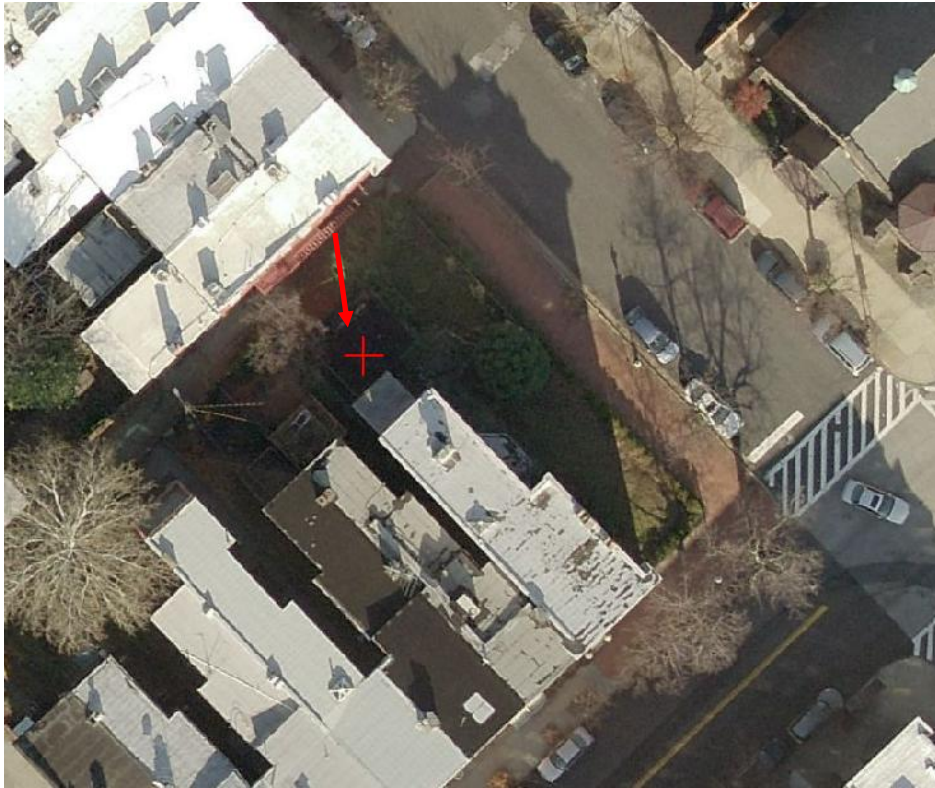
Aerial View

The applicant purchased the home in September and received a violation notice in October due to the poor condition of the garage. The garage is currently in a state of near-collapse, with a large structural crack down the side.

Unlike other garages in the neighborhood, the garage at 222 W. Lafayette Avenue was not built as a carriage house around the time the house was constructed. Typical carriage houses in Bolton Hill are of brick construction and may feature details from the main house. More utilitarian garages and carports have been built over the 20th century along the alleys of Bolton Hill. Historic mapping of this property into the 20th century shows the house without a garage. The garage lacks any architectural association with the house on the property. Although the garage is not modern, many of the original details like doors and windows have been replaced and the building has lost its structural integrity.

The garage at 222 W. Lafayette Avenue has lost its historic integrity, is deteriorated beyond repair, and no longer contributes to the local historic district. Staff recommends approval of demolition of garage as the garage no longer contributes to the Bolton Hill Historic District.

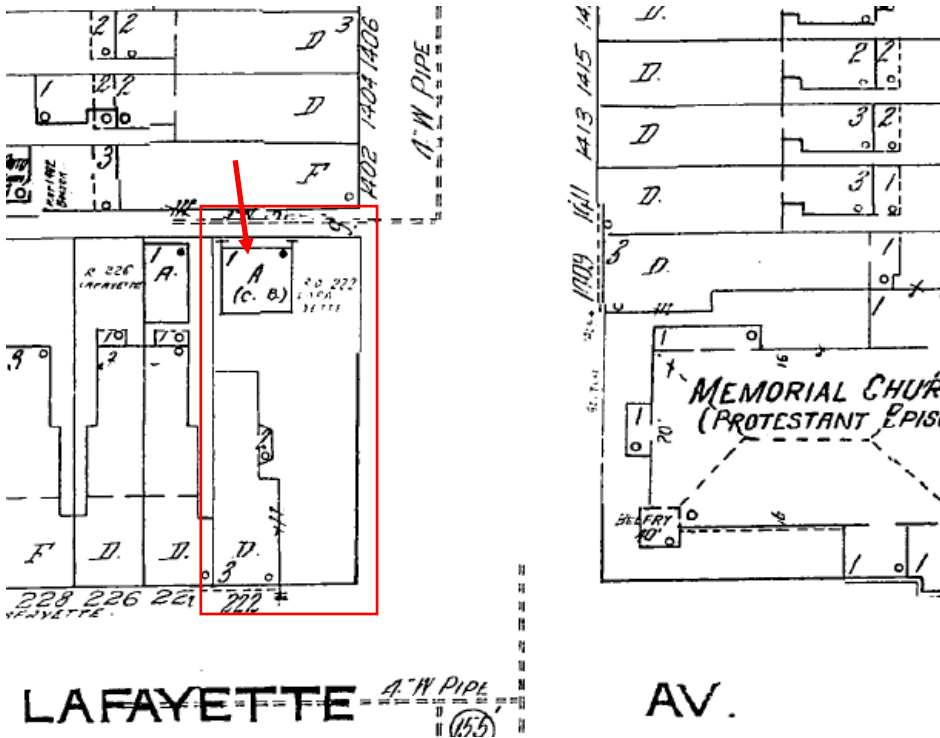
1951 Sanborn Map (Garage is present)
